BioPlant Removal

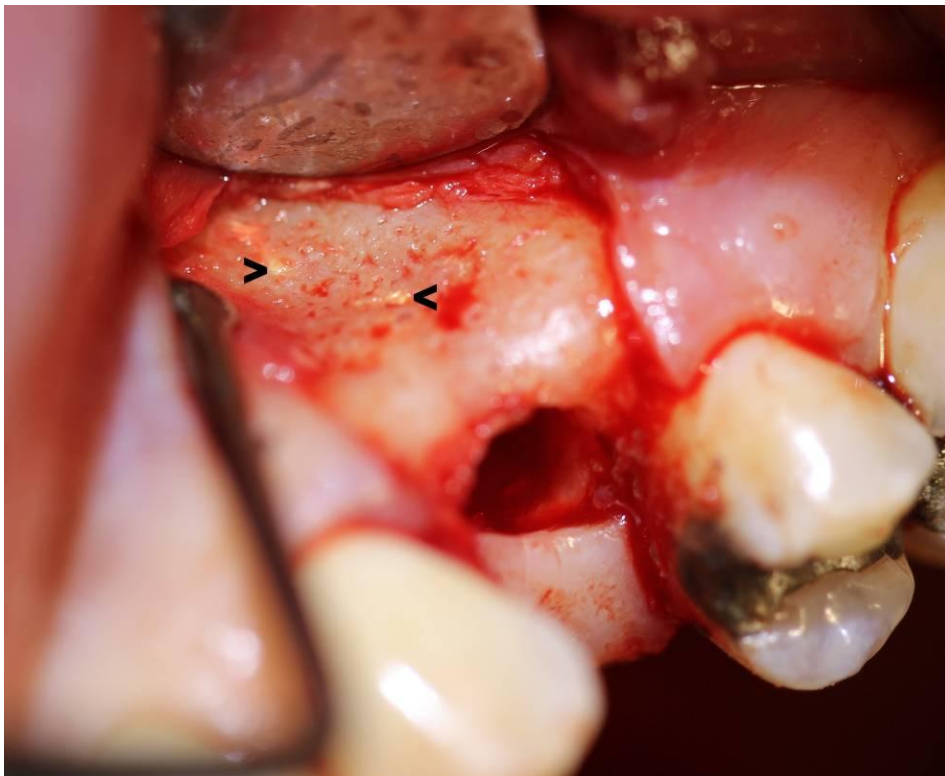
However, when the flaps were raised it was obvious the material had spread throughout the bone. The arrows point to the white graft material on the surface of the buccal wall. The bone bled profusely.

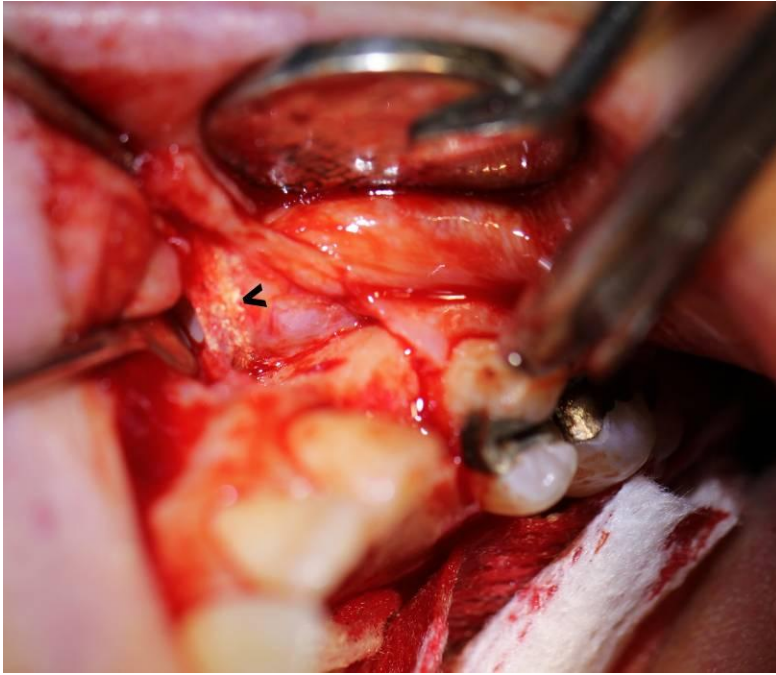
This photograph shows graft material had migrated into the buccal flap.

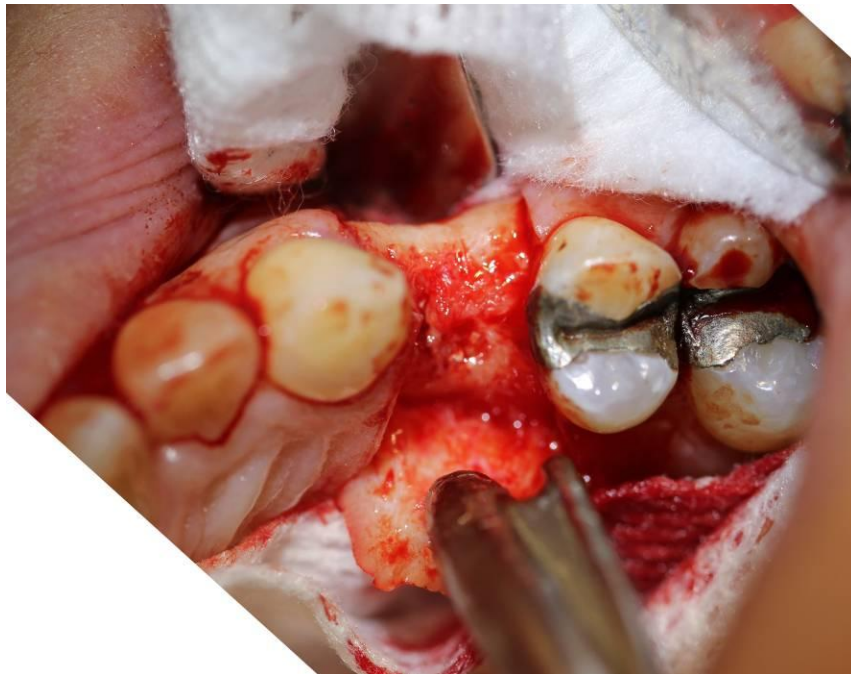
The crest was poorly mineralized. When the initial incisions were made the incisions bleed profusely. Gauze was needed throughout the surgery to assist in controlling the bleeding.

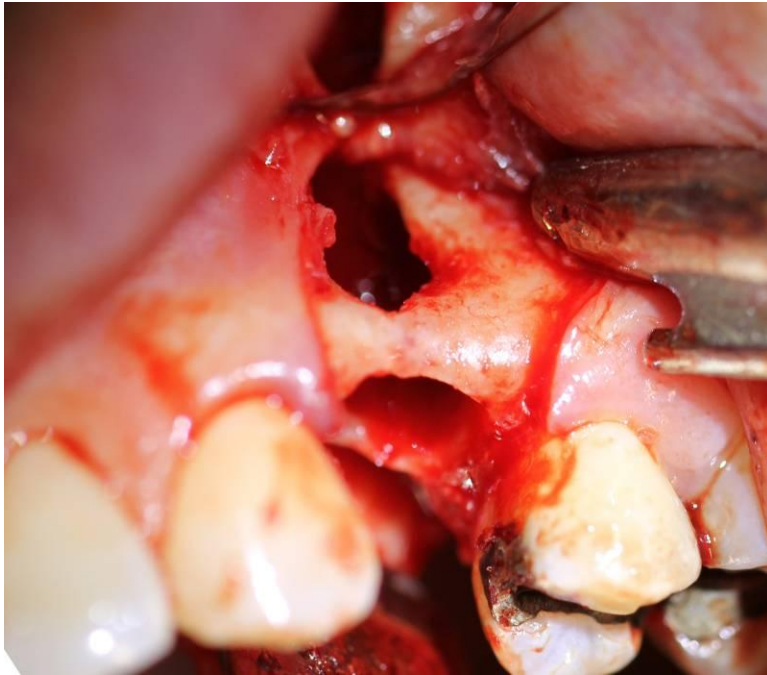
With the intense bleeding it was clear this material was not biocompatible and the only chance for normal bone to form it would be necessary to completely remove all of the graft material that was causing the inflammation. The buccal wall needed to be completely removed and the graft material was dissected out of the buccal flap.

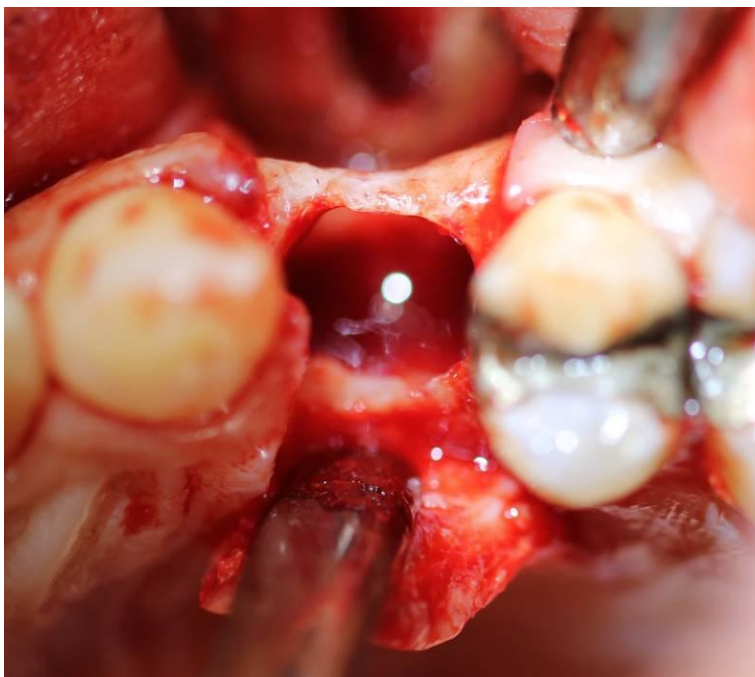
The graft material had migrated throughout the alveolar ridge and the bone needed to be removed from the lamina dura of #11 to the lamina dura of #13. At this point with nearly complete removal of the graft material the bleeding from the gingiva and bone stopped abruptly.

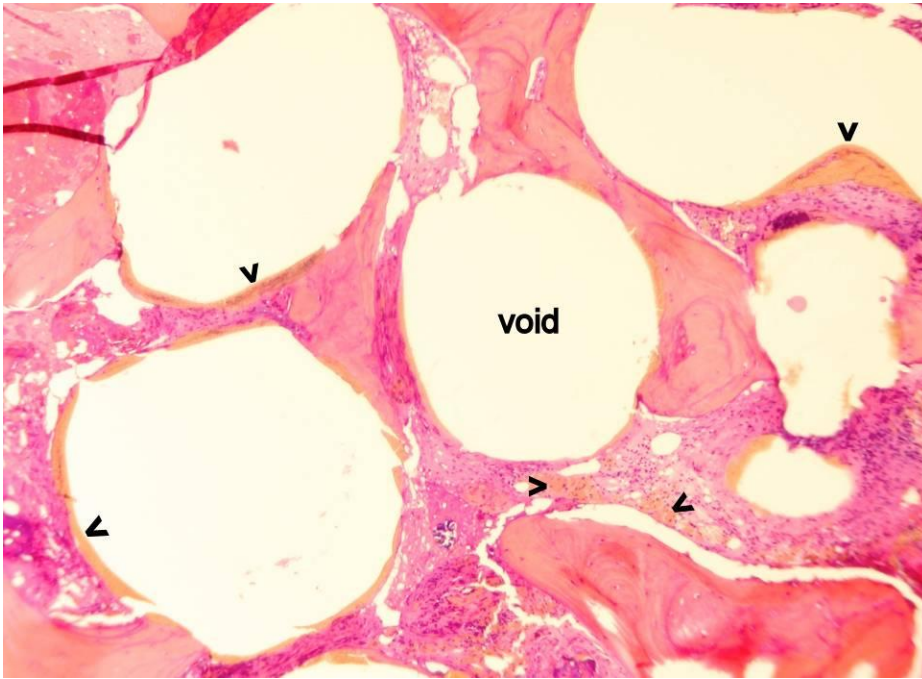
This is a low power photomicrograph of the core sample taken with a long narrow bur. The voids are where the plastic beads were dissolved for processing the specimen for microscopy. A surprising finding was the presence of granular material that coated the beads (black arrows)

and spread throughout the tissue. The bone formed is sclerotic bone.

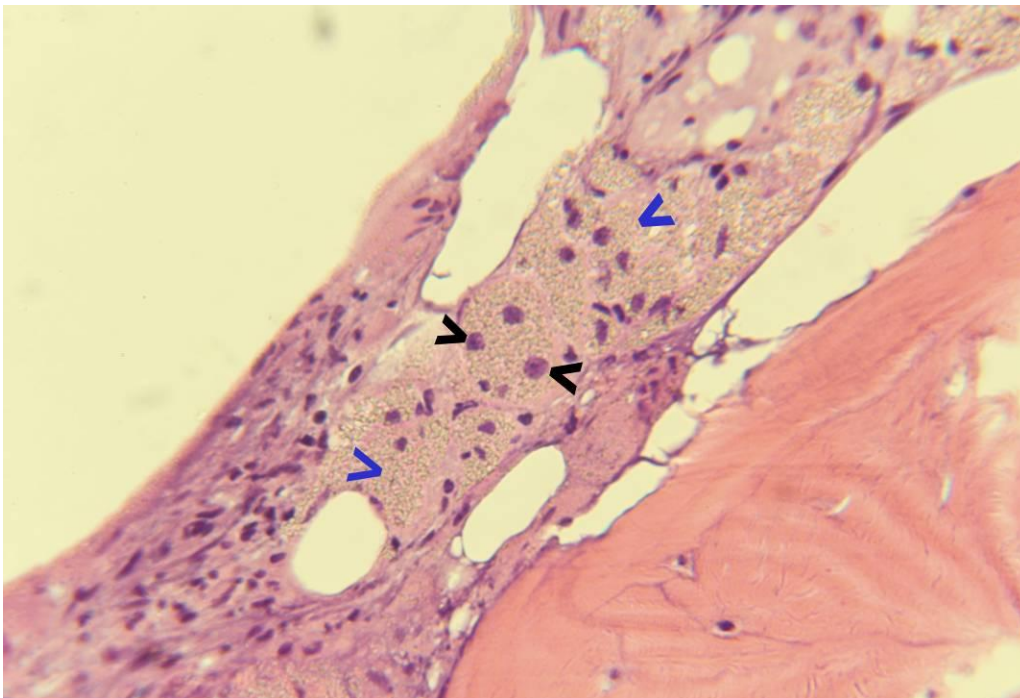
This high power photomicrograph shows classic histiocytes filled with the nonresorbable material that coated the plastic beads. Black arrows show histiocytes nuclei.

Blue arrows show histiocyte cytoplasm filled with the granular foreign material.

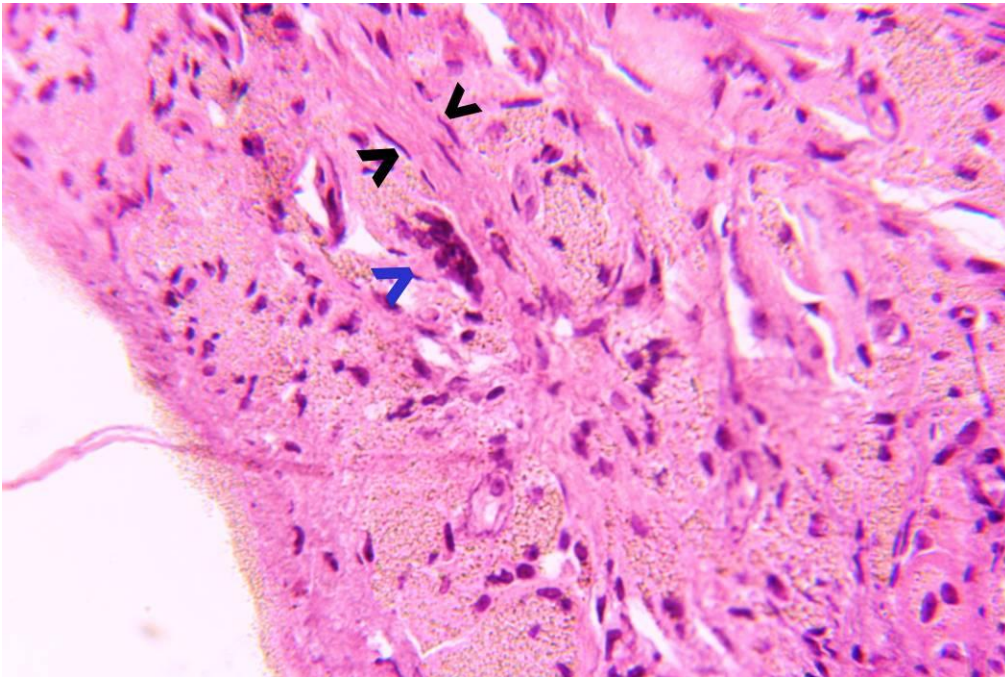
The blue arrow points to a multinucleated giant cell which is the result of histiocytes joining together. The black arrows point to fibroblasts that have laid down fibrous barriers in an attempt to contain the material that coated the plastic beads.

The intense bleeding during

surgery was a result of the foreign body reaction to the nonresorbable material that coated the plastic beads and spread throughout the tissue. Once the material was removed it was surprising how quickly the bleeding stopped not only in the bone but also the surrounding gingival tissue.

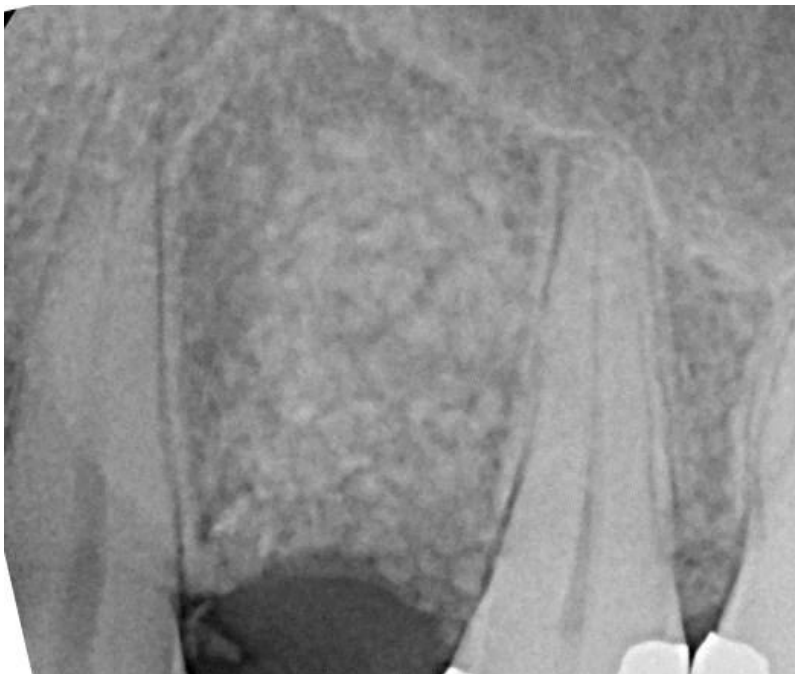
The assumption that the material was biologically inert lead to the conservative flap design which resulted in the mistake of placing the incision over the area being grafted. The cardinal sin of bone grafting.

The mesial buccal incision opened and a significant amount of graft material was lost which will surely

compromise the graft result. It is not surprising why the FDA does not allow implant placement in this material.

The site was grafted with resorbable biocompatible graft materials approved for implant placement.
