Case #1 of 10 consecutive extraction sockets grafted with Socket Graft Putty, covered with Socket Seal and sealed with Periacryl. I D # HEU This patient is a 66 year old female.

10 consecutive Socket Graft Putty cases.

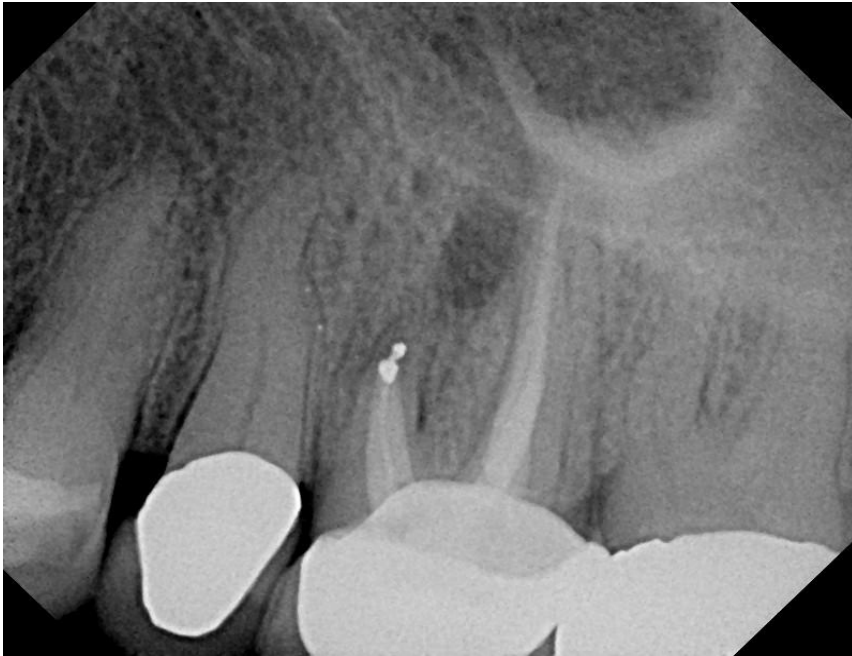
Pre op Failed endodontic treatment with sinus involvement.

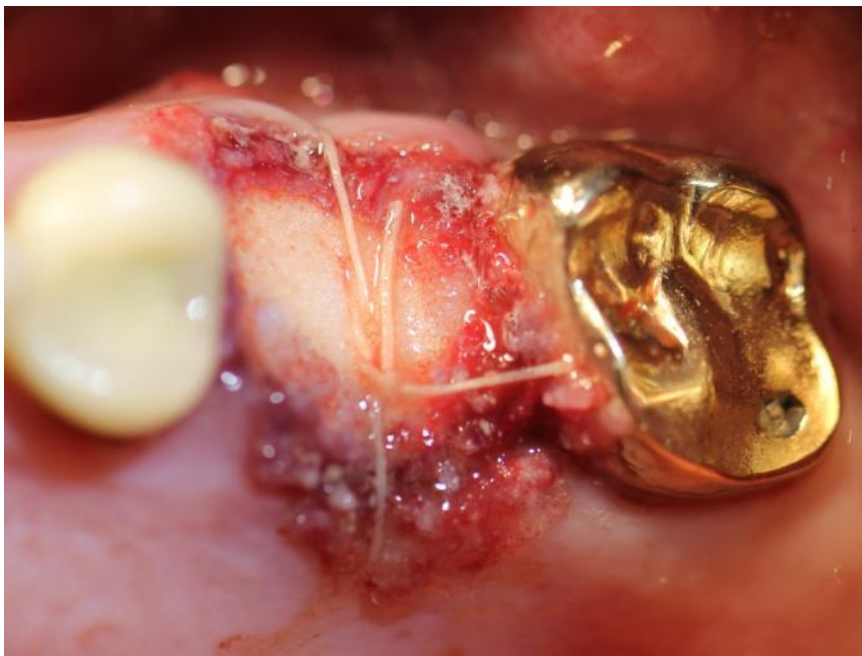
#14 extracted, grafted with Socket Graft Putty, covered with Socket Seal and glued with Periacryl. We now advise a couple more passes through the Socket Seal in criss-cross fashion. The seal is removed in one week

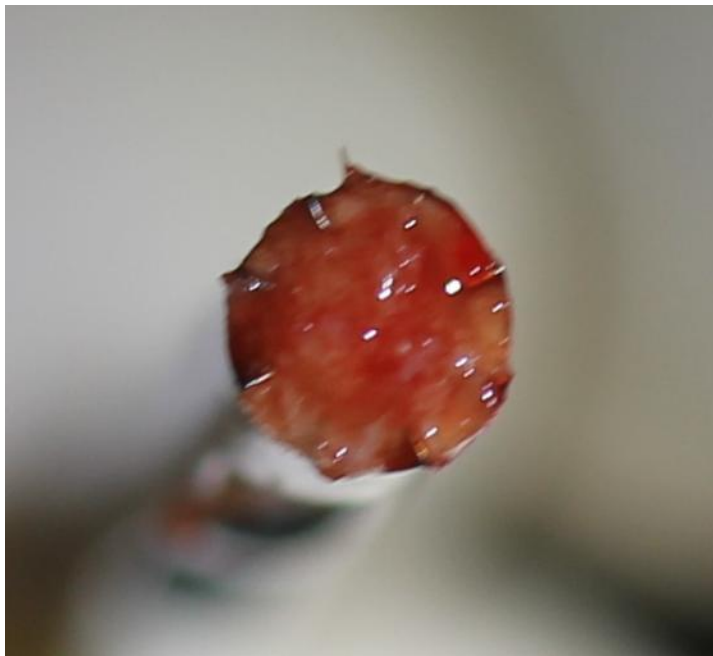
Core sample shows well vascularized vital bone. You might want to compare this tissue with a core sample taken from a Bio-Oss graft site that can be seen at <http://www.steinerlabs.com/bioosslecturehistology.shtml>

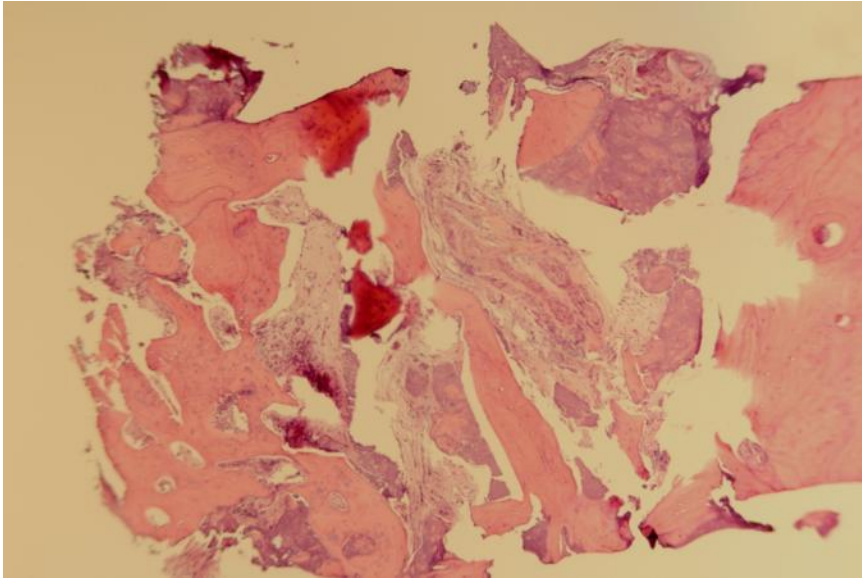
In this histology the core laying on its side with the crest on the left. The crest is densely mineralized with cancellous bone.

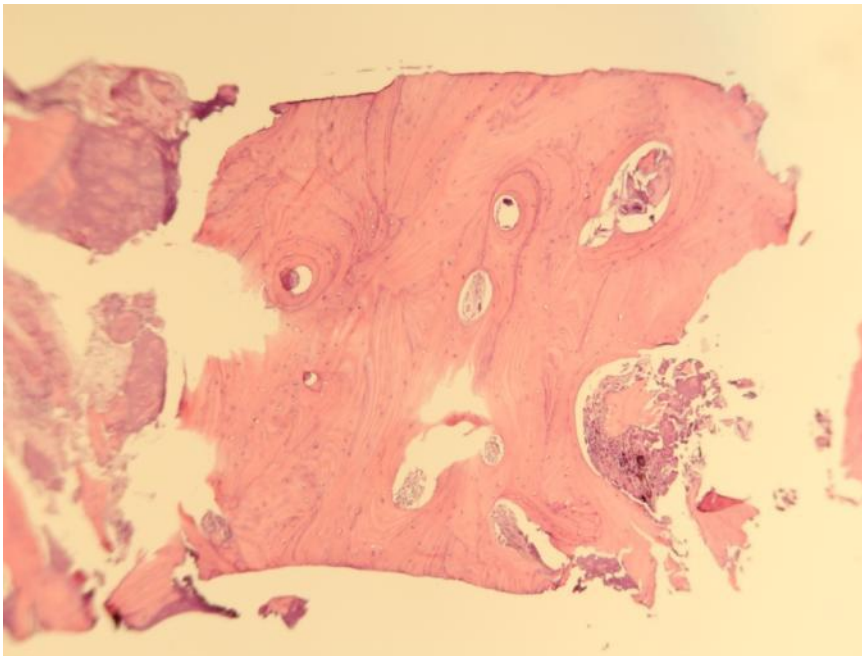
This is the apical portion of the core sample. At this point the spaces between the trabeculae have filled to produce a solid mineralized structure with the exception of the vascular supply. Over time due to the stimulation of the osteoblasts Socket Graft Putty graft sites mineralize completely with the exception of the vascular supply. However when the bone is loaded the bone remodels and trabeculae form according to the load placed on the tissue.

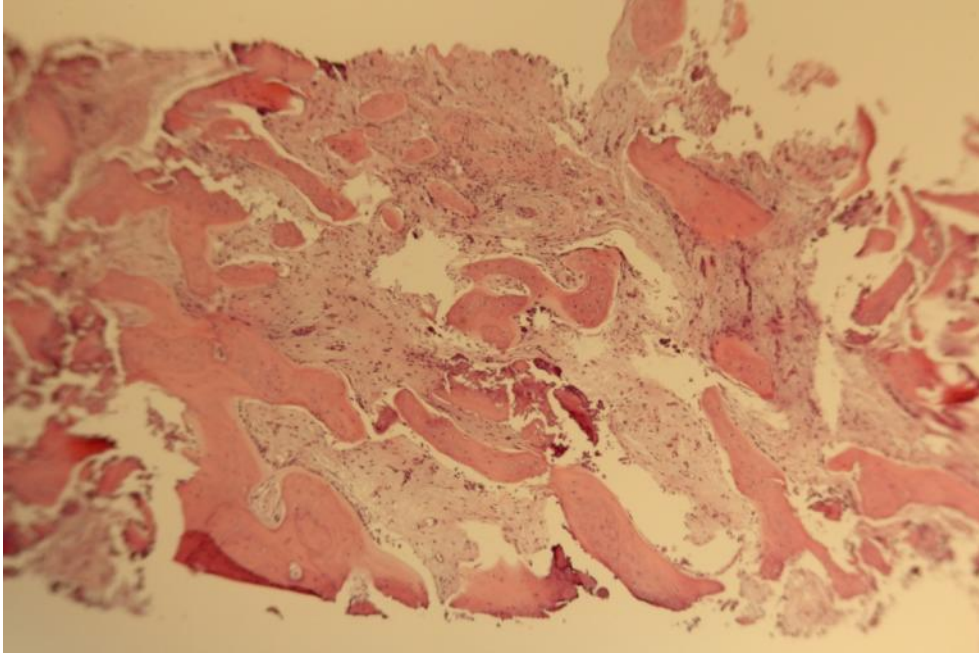
After 8 weeks woven bone is forming with no inflammatory cells. Virtually all of the graft material has been resorbed.

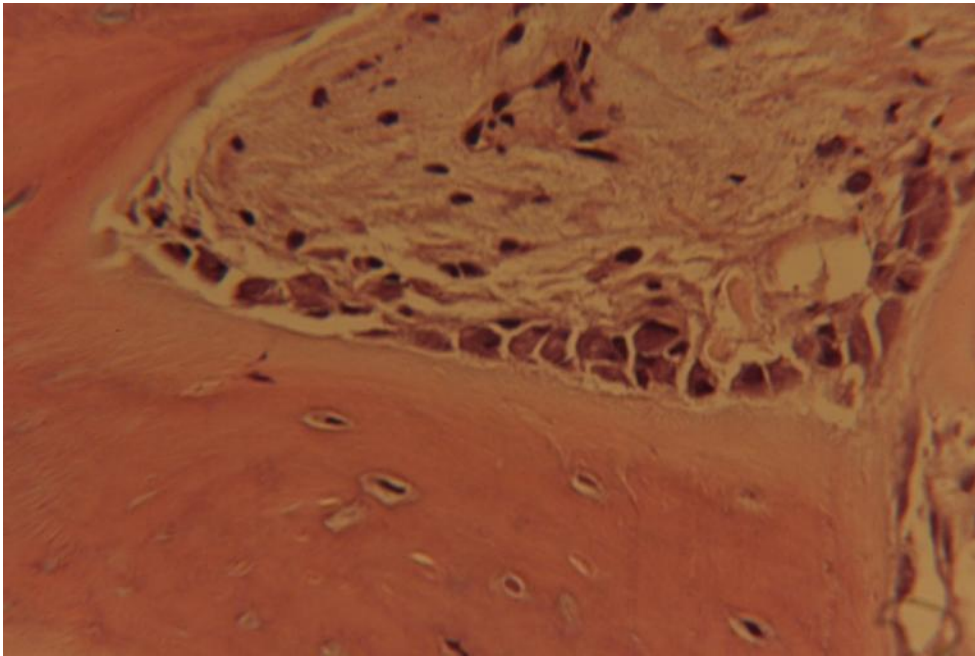
A high power of the previous histology shows a proliferation of osteoblasts lining recently formed osteoid.

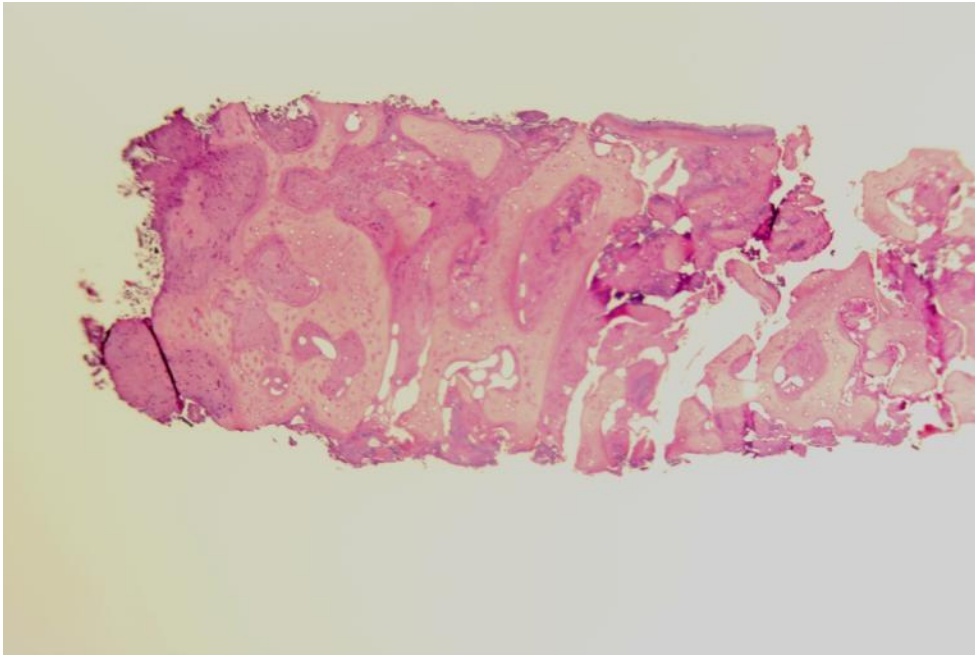
This shows the histology of the coronal portion of the core sample. The alveolar crest is on the left. When grafting with biocompatible bone grafts the surrounding bone remains intact so the bone on this portion of the core sample has formed over the interradicular bone. The bone on the left of this section is newly formed woven bone.

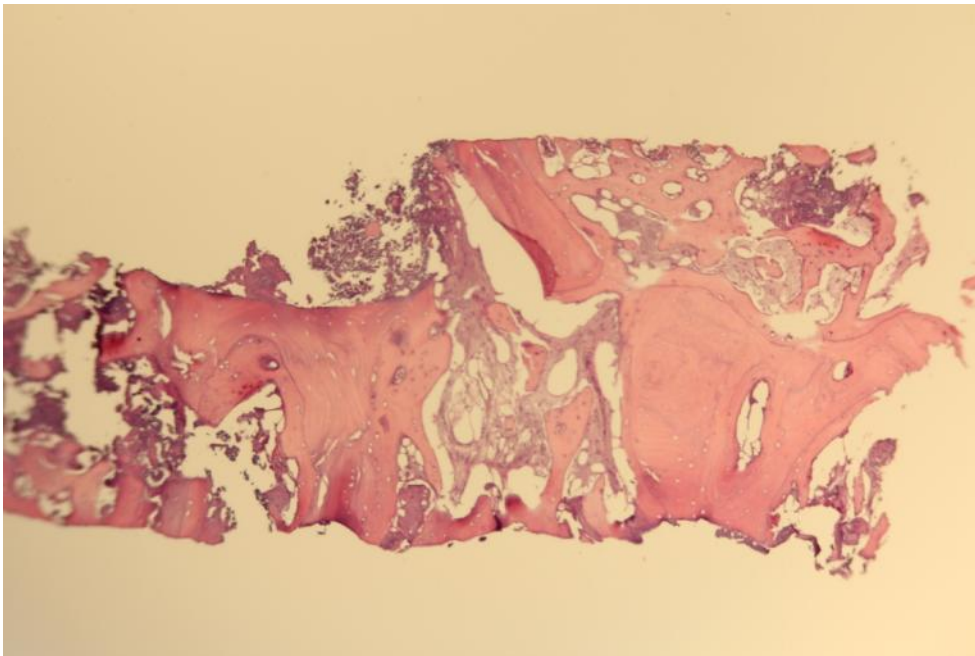
This histology is from the apical portion of the core sample. The bone in this section is laminar bone from the preexisting interradicular septum.

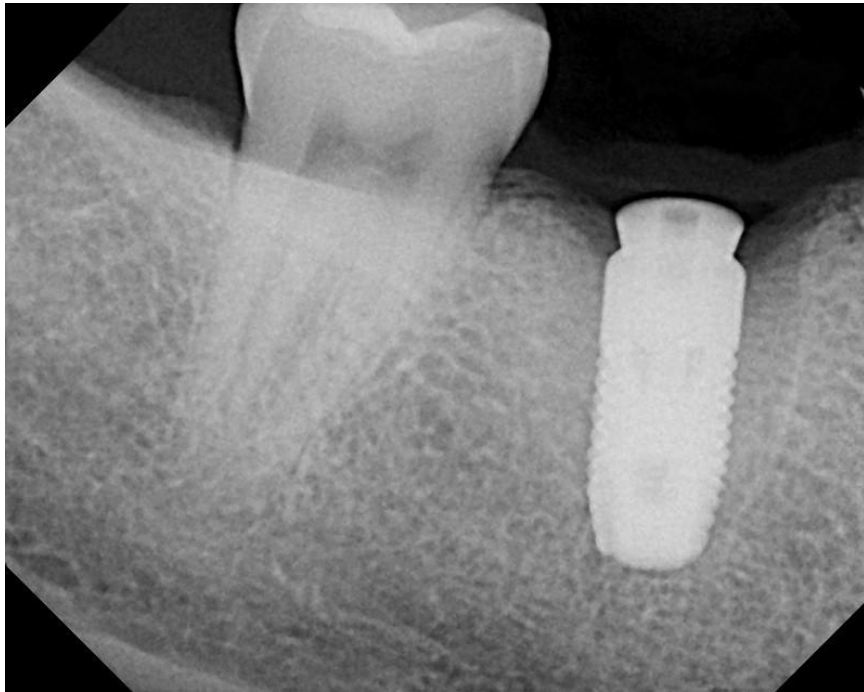
Day of implant placement. With the implant in place the original lamina dura can be seen to the mesial of the implant as the implant is located in the area of the original interradicular septum. At this stage of bone maturity the radiographic bone density in the grafted area is equal to or greater than the surrounding bone.

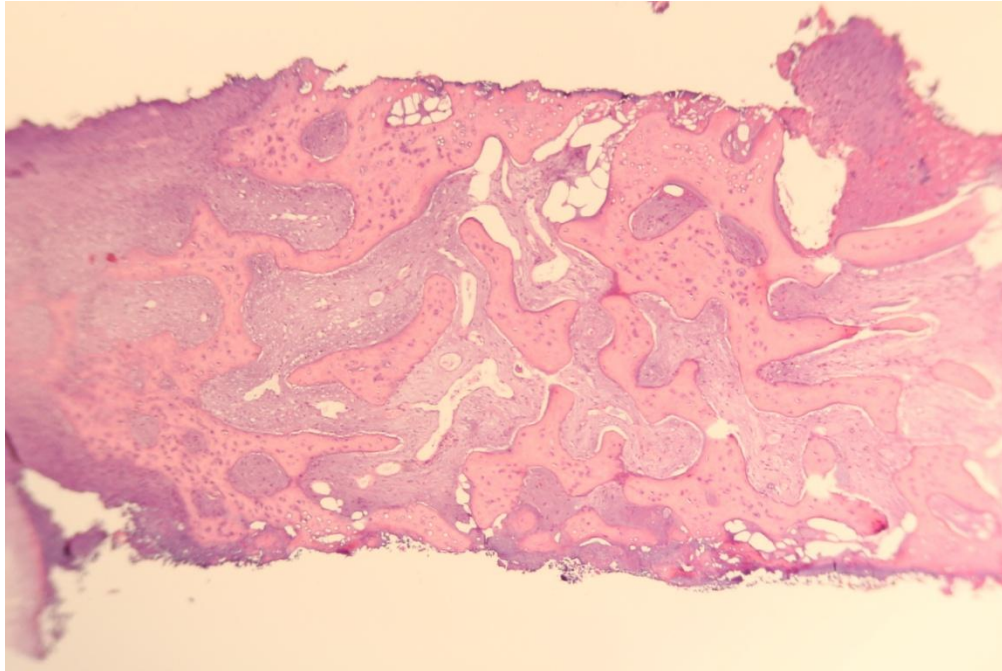
The crest is on the left. The bone core sample at 11 weeks shows approximately 50% mineralization with newly formed woven bone. Only traces of the putty and granules remain.

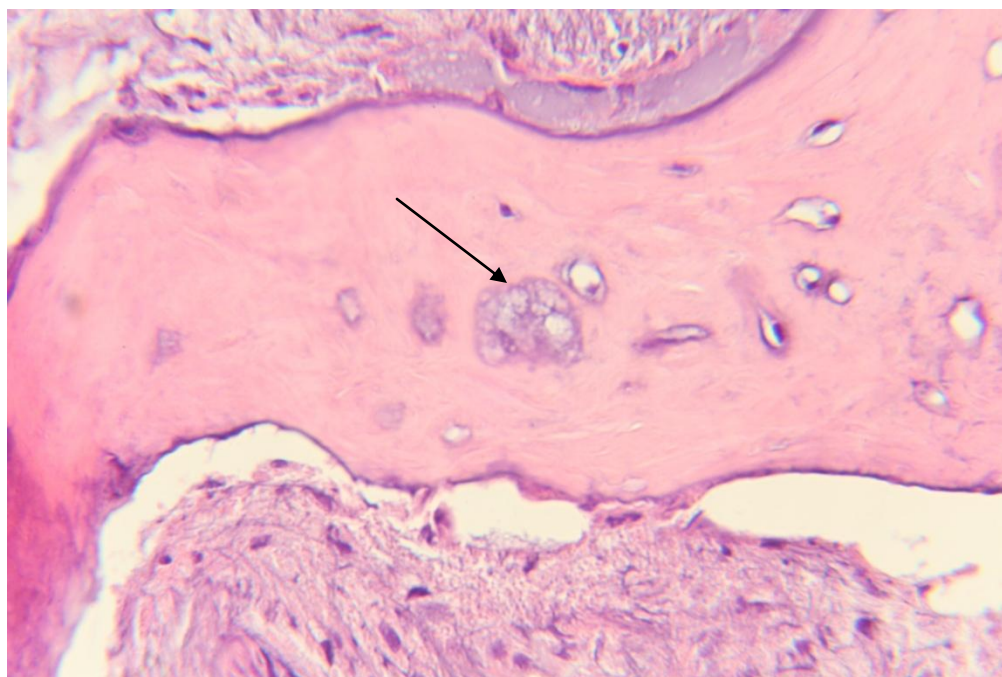
The arrows show remaining Socket Graft Putty graft material.

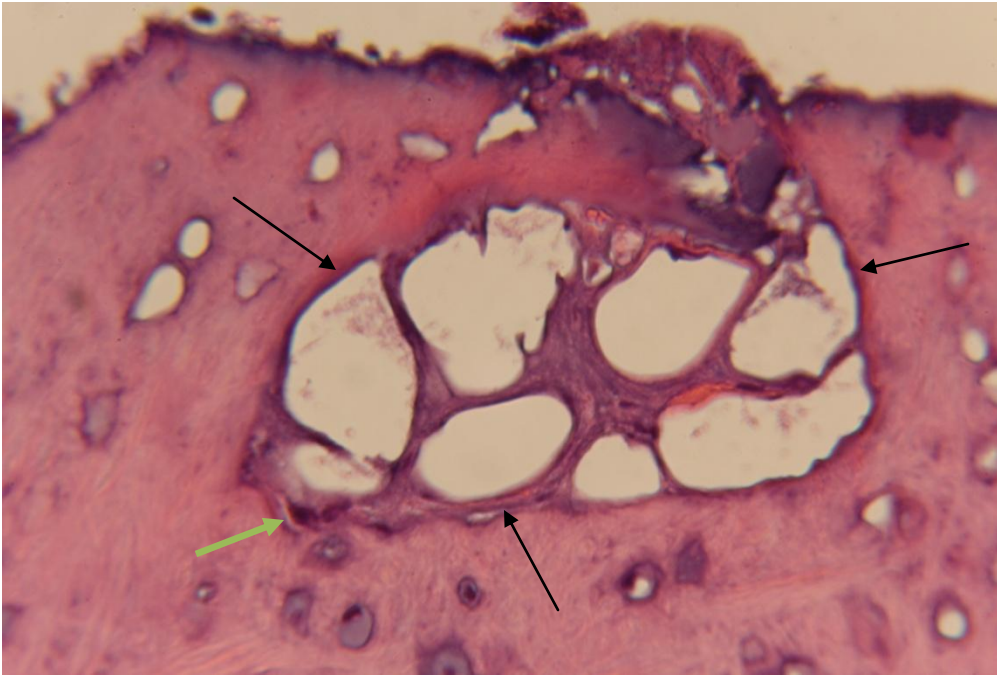
Because the core sample has been demineralized, the Osseoconduct

BTCP granule shows as a void as identified by the black arrows. This is one granule that is being resorbed and the histology demonstrates how the soft tissue grows through the granule as it is being resorbed. The yellow arrow appears to be an osteoclast. The process needs to be envisioned from a 3D perspective.

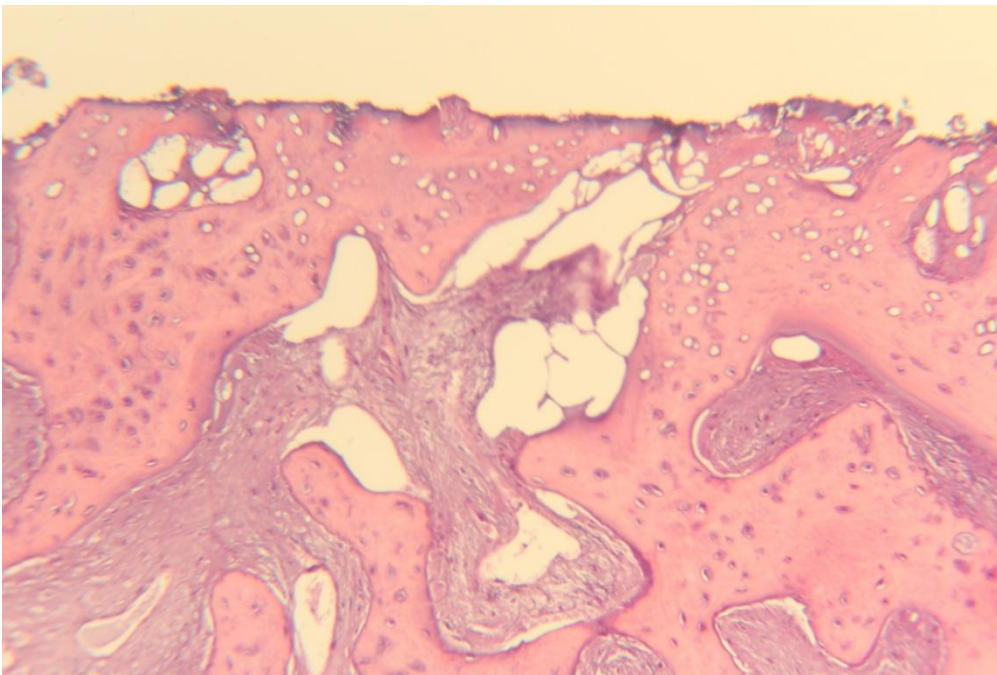
As a note of interest the upper portion of the core sample shows the portion of the

core closest to the trephine. The area of bone along the edge of the core sample shows osteocytes (small white spots) void of cellular contents. Further into the core sample the osteocytes are filled with cellular contents. The heat generated by the trephine kills the osteocytes (bone burning) and in the process the cellular contents degenerate leaving a void.

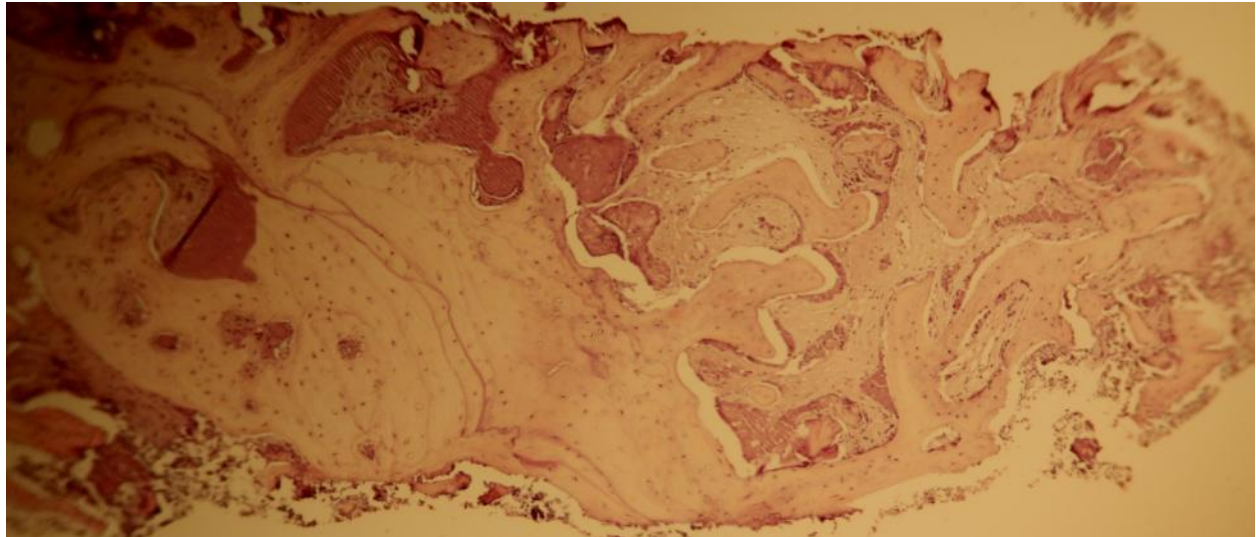
Core sample. The crest is at the right of the core sample. The core sample consists of newly formed woven bone.

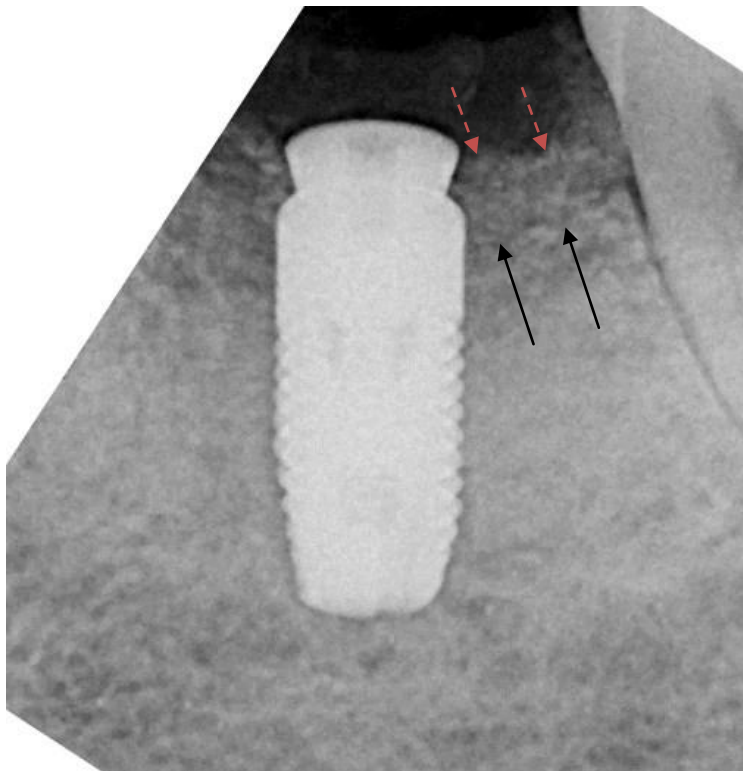
Day of implant placement.  
Implant spun upon torqueing leaving approximately 3mm of exposed threads.

Arrows indicate area of grafted threads with Regen Biocement Putty mixed with Osseconduct perio size granules no membrane was used .

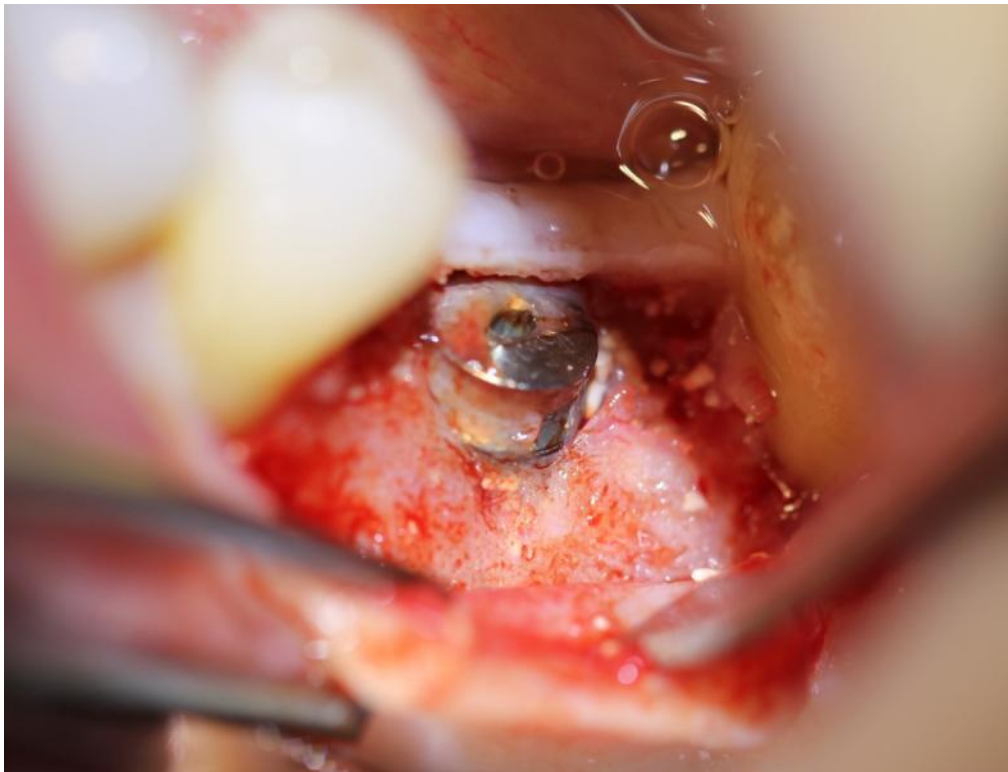
Nine weeks after implant placement and grafting the threads are covered with the exception of the 1<sup>st</sup> buccal thread. Residual Osseous granules can be seen in the newly formed bone around the coronal portion of the implant.

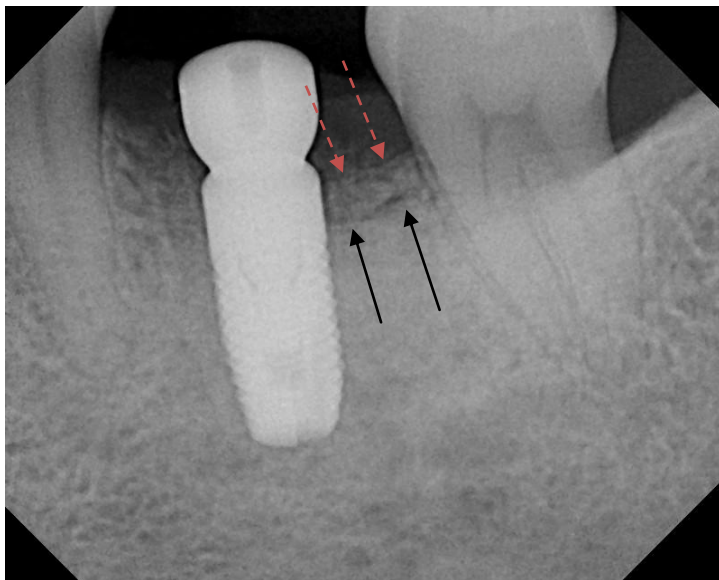
Healing abutment placement, nine weeks after implant placement. The previous alveolar crest can be seen as noted by the black arrows. The area grafted at the time of implant placement can be seen between the arrows.

Irrespective of implant spinning at time of placement, the implant was well integrated at time of healing abutment placement.

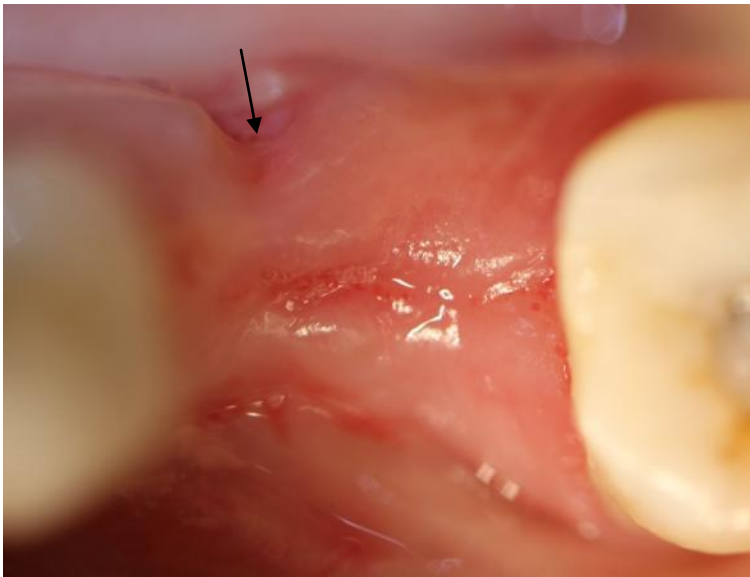
10 weeks post extraction. Lingual cleft remains (arrow indicates) in the area of lingual cortical bone perforation that occurred during extraction.

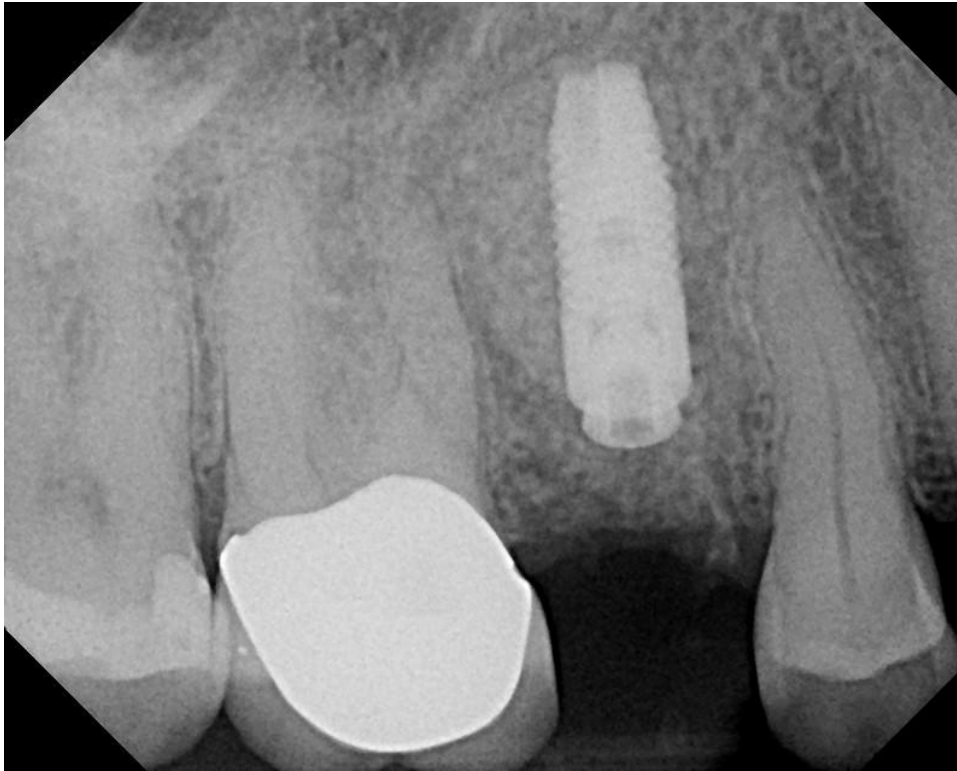
Radiograph shows implant placement in graft material only with no bone contact.

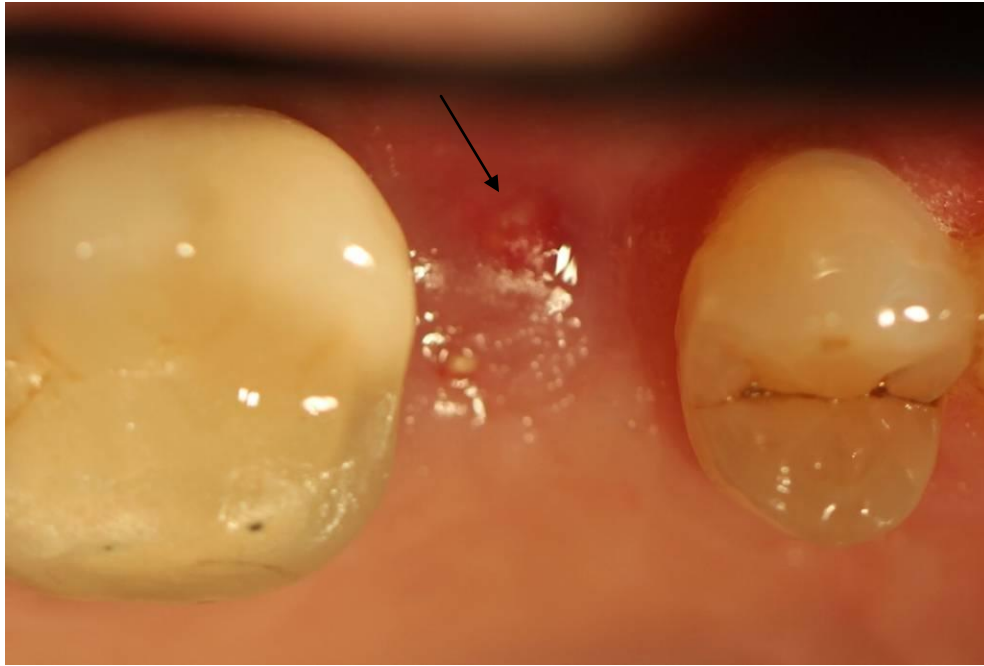
Day of healing abutment placement. During the integration phase a fistula persisted noted by the arrow. The fistula is assumed to have been formed due to a loose cover screw. During the time of implant placement the cover screw was unable to be tightened due to the implant floating in graft material and not having bone retention.

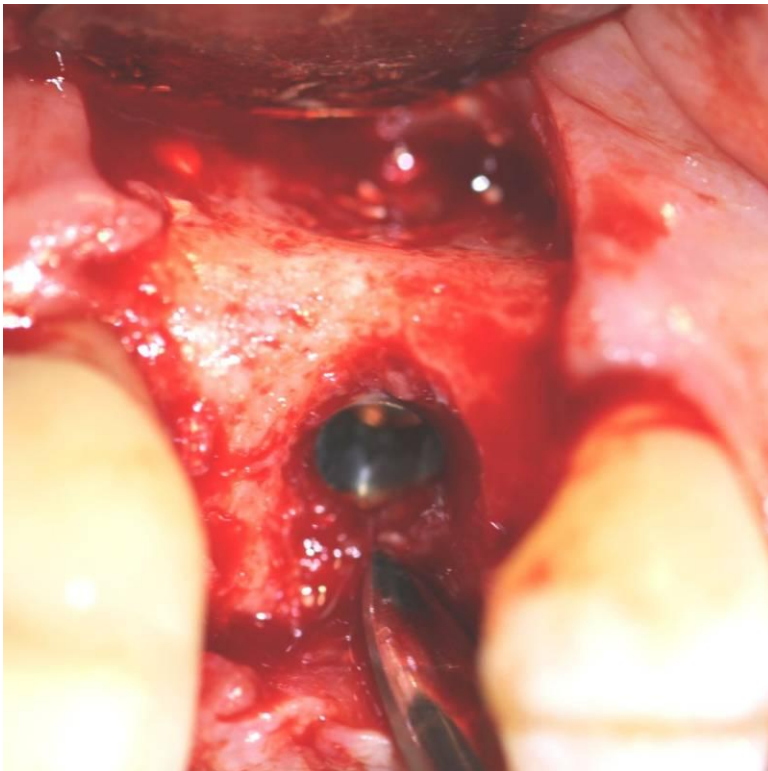
Healing abutment appointment. The implant is fully covered with bone and solidly integrated. The healing abutment was placed on March 19, 2014. Three months after implant placement.
