## Socket Graft Plus™

Case floated in Socket Graft Plus™ with NO bone contact.

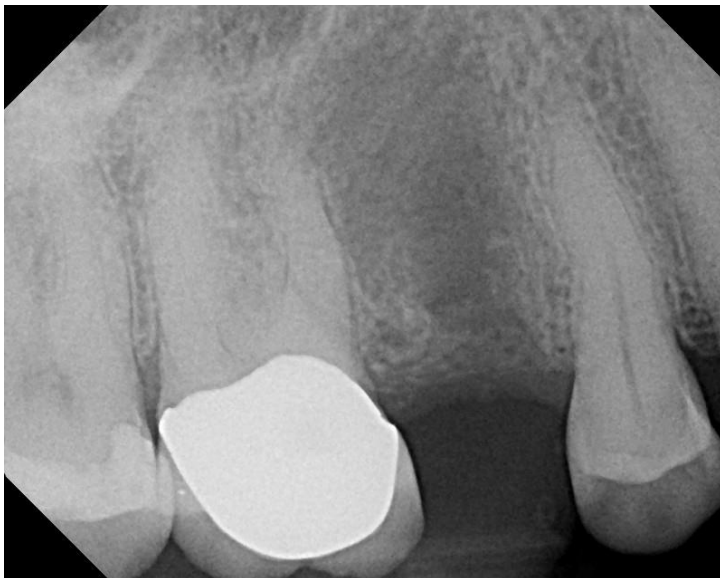
72-year-old female patient presents with poor mineralization of #4.

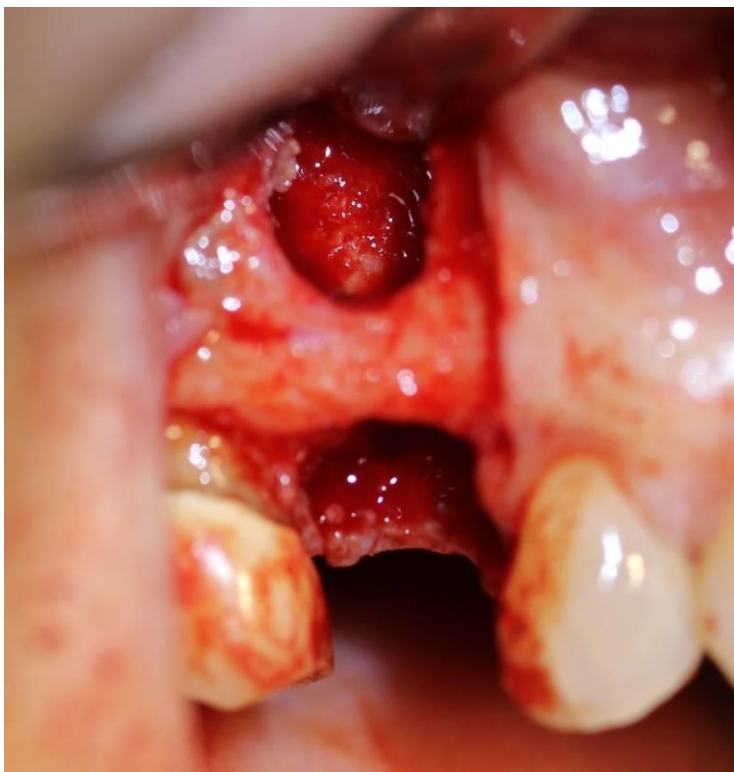
After flapping the tissue, granulation tissue is removed, with no bone formation in the extraction site.

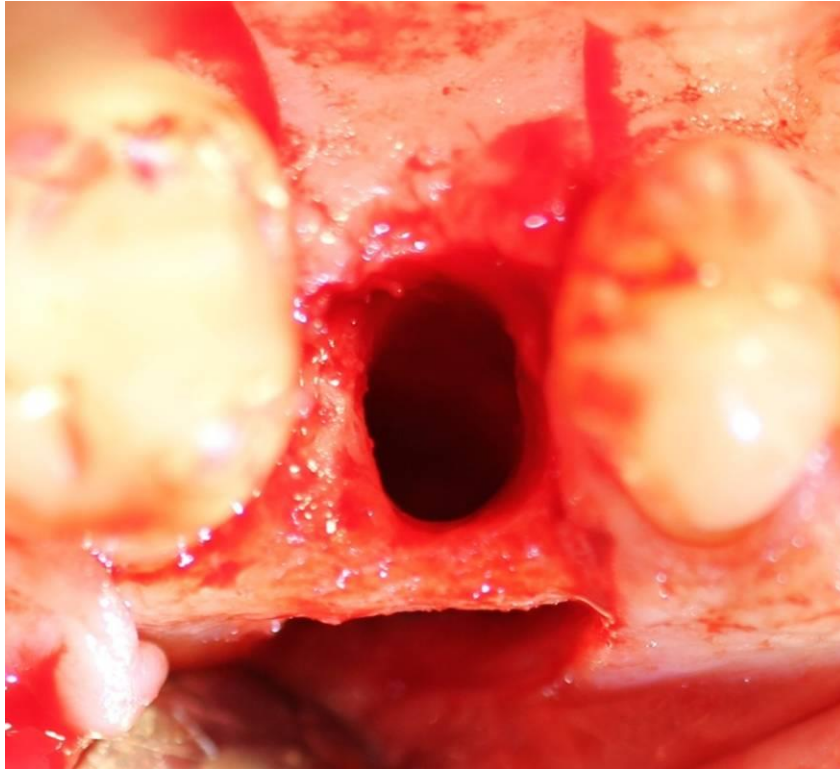
Occlusal view of implant site.

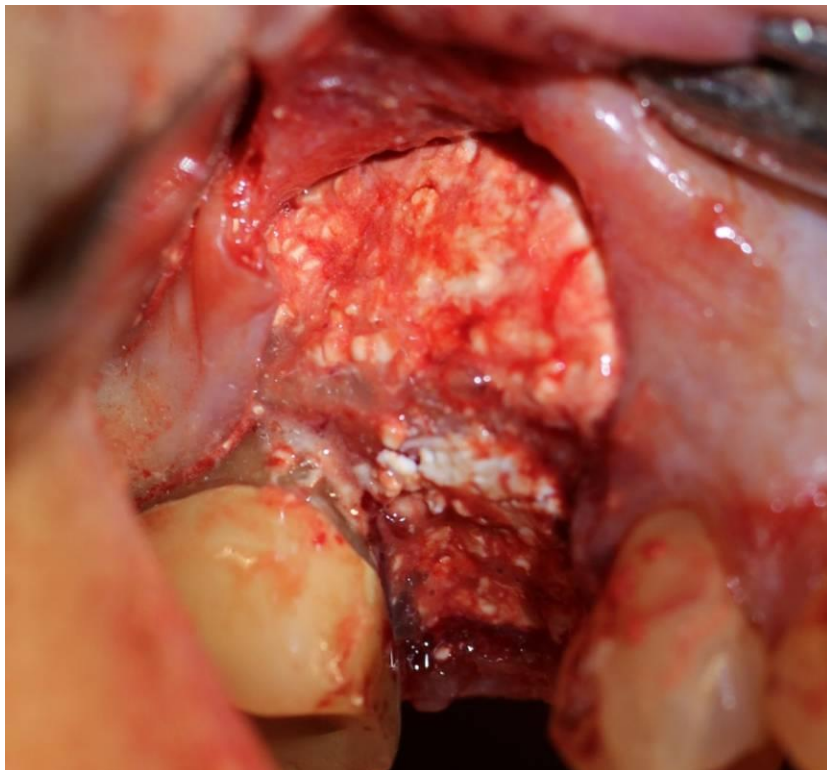
The implant site was grafted with Socket Graft Plus™

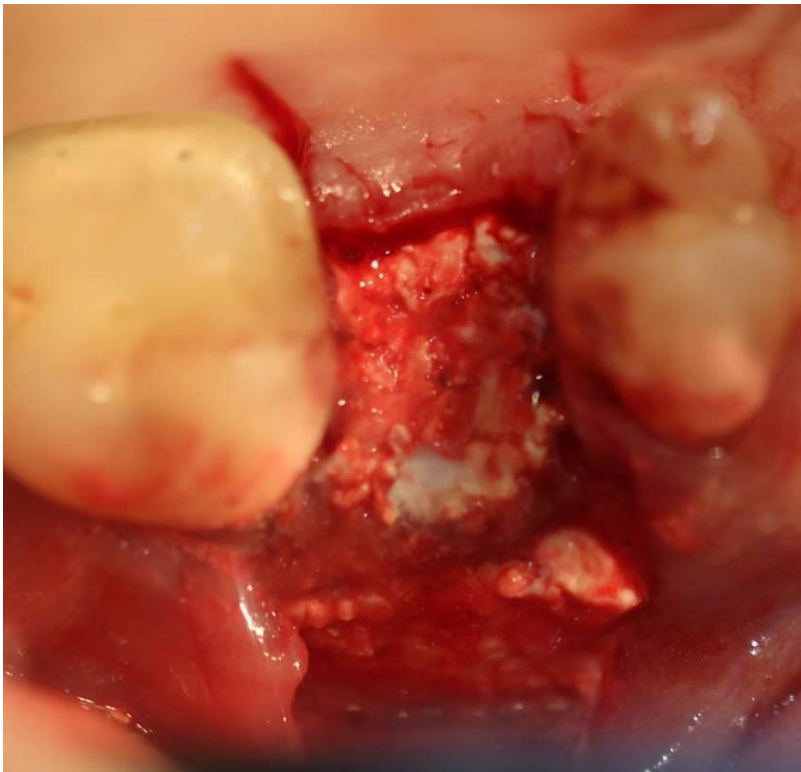
Occlusal view of implant site. The implant was placed in the graft material at the time of grafting. A 4mm x 11 mm Astra implant was placed in the graft material with no bone contact. The graft material and implant were placed on December 18, 2013.

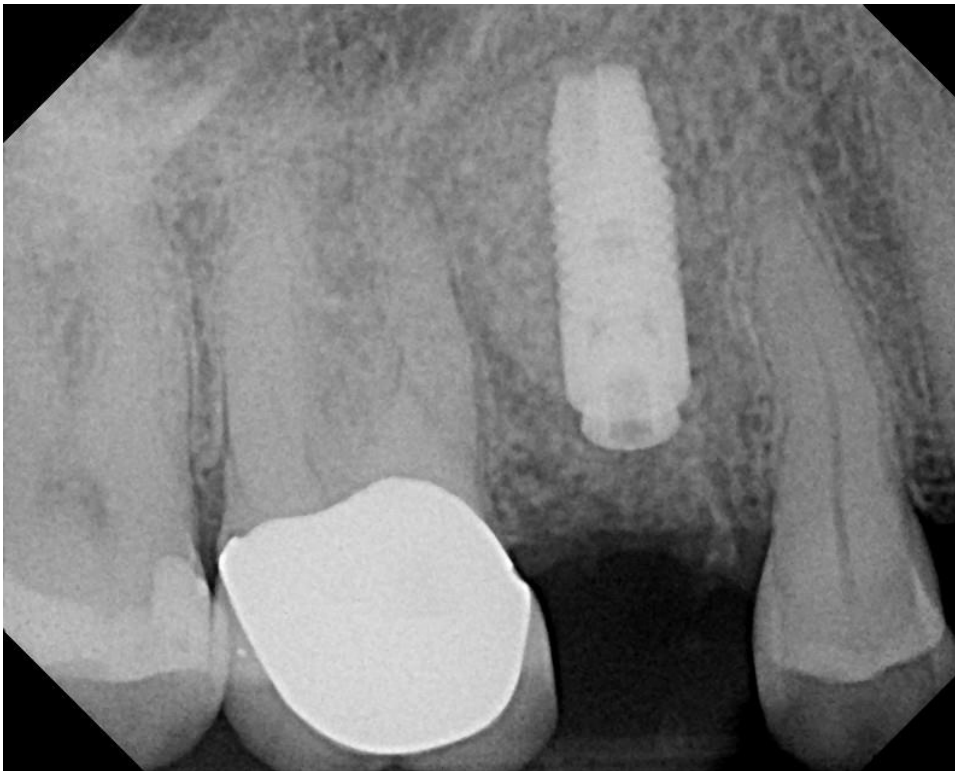
Radiograph shows implant placement in graft material only with NO bone contact.

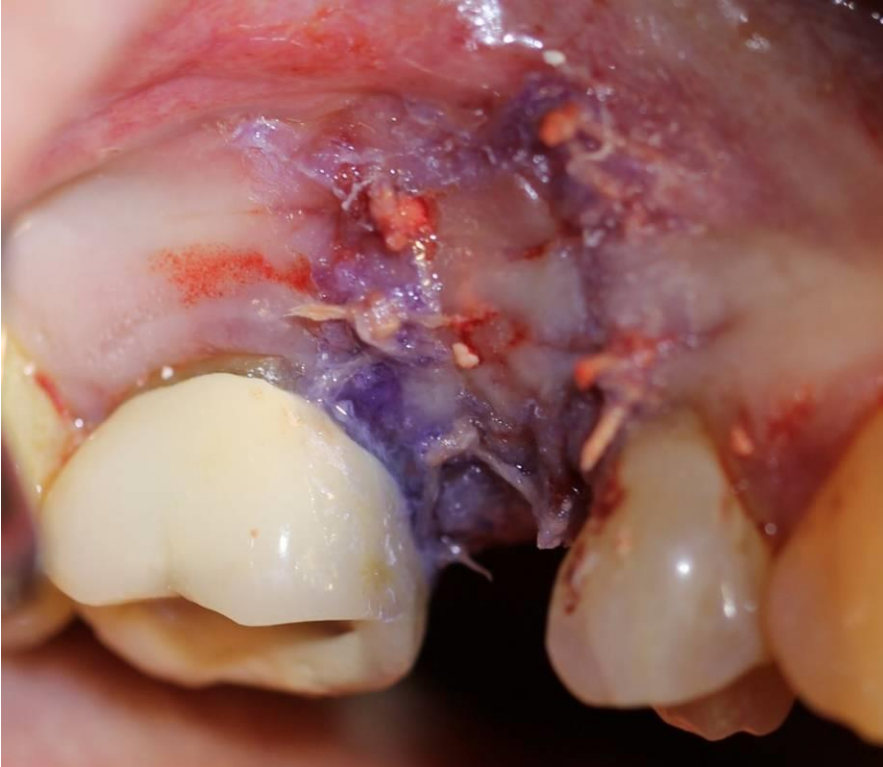
The surgical site was sutured and bonded with PeriAcryl adhesive.

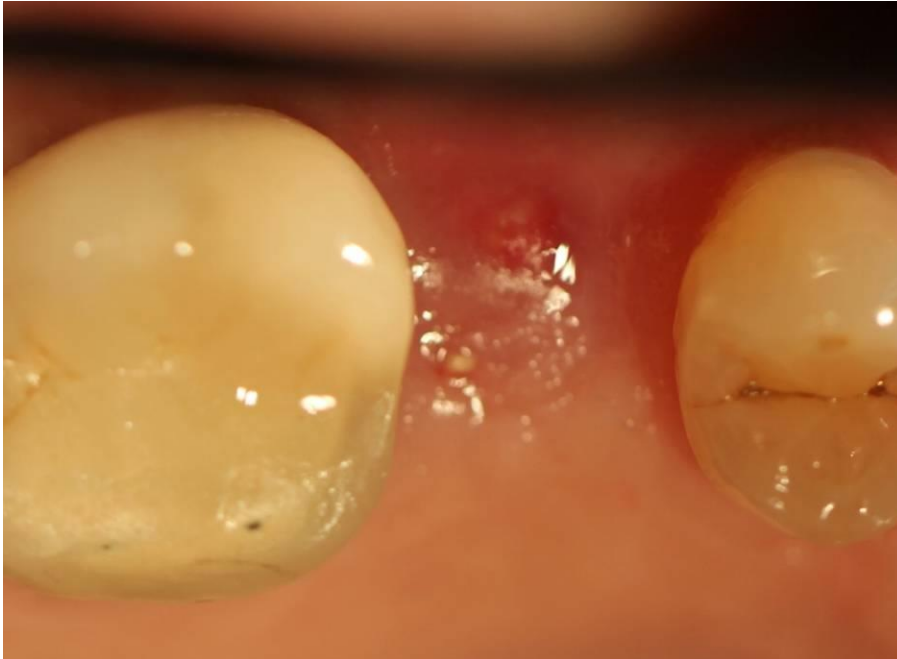
Day of healing abutment placement. During the integration phase a fistula persisted noted by the arrow. The fistula is assumed to have been formed due to a loose cover screw. During the time of implant placement, the cover screw was unable to be tightened due to the implant floating in graft material and not having bone retention.

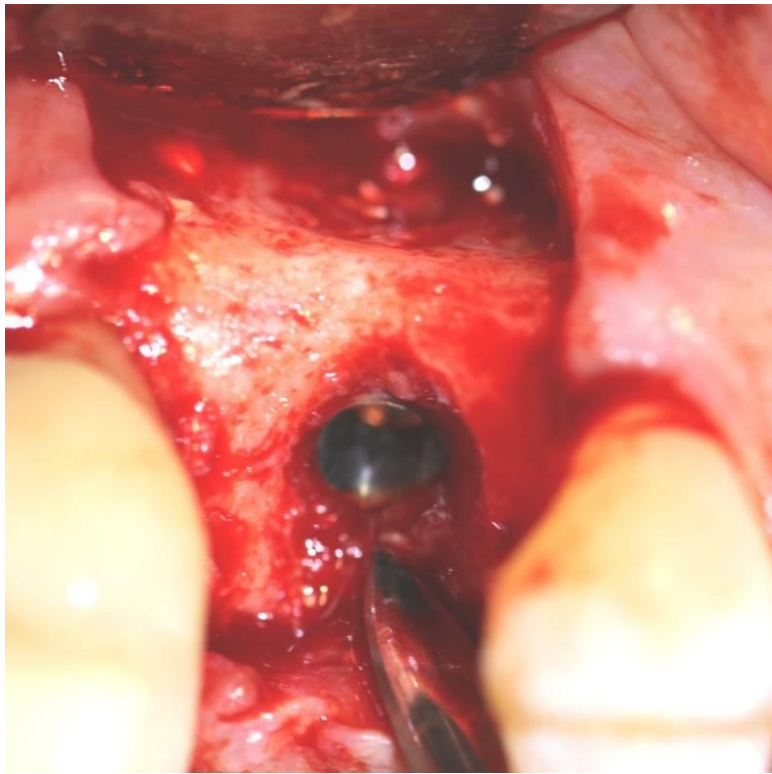
Healing abutment appointment. The implant is fully covered with bone and solidly integrated. The healing abutment was placed on March 19, 2014. Three months after implant placement.

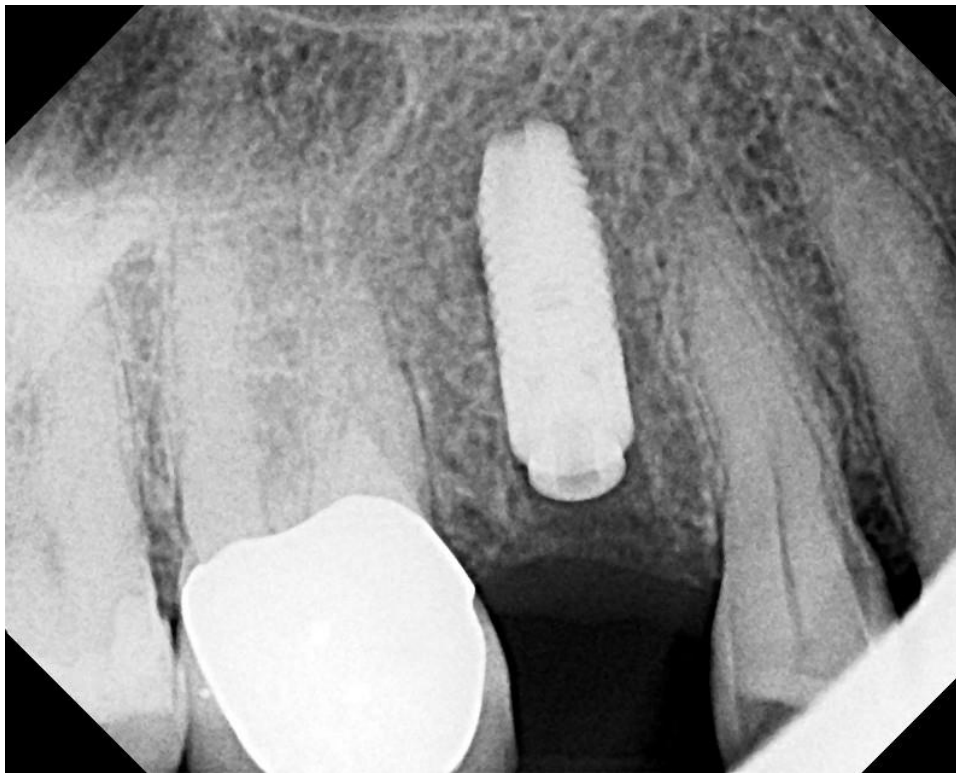
Healing abutment appointment radiograph. This case demonstrates the ability of Steiner Laboratories regenerative products to produce integration through graft material. This case demonstrates the ability of Steiner Laboratories products to produce integration in the grafted area of immediate implants.

Allografts and xenografts have been shown to not produce integration in grafted areas on immediate implants. No other graft material has shown the ability to integrate through the graft material even when the implant has primary stability in bone.
