BioPlant Removal

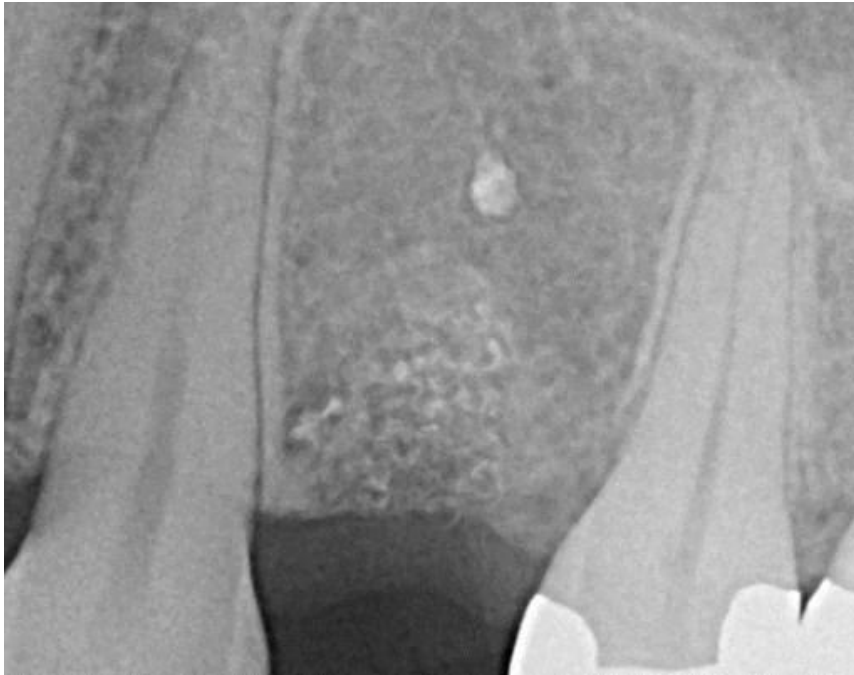
The patient presented 3 years after extraction and grafting with BioPlant. The patient was informed that the FDA does not permit implants to be placed in this material and that she could have the material removed or she could find another clinician to place the implant. She chose to have the material removed.
